**State Bar of Arizona Committee on Persons With Disabilities  
Accessibility Committee Site Visit  
Tonto Apache Tribal Court  
Tonto Apache Reservation #30  
Payson, Arizona**

**Facility:** Tonto Apache Tribal Court, Tonto Apache Reservation #30, Payson, Arizona, 85541

**Date:** April 26, 2004

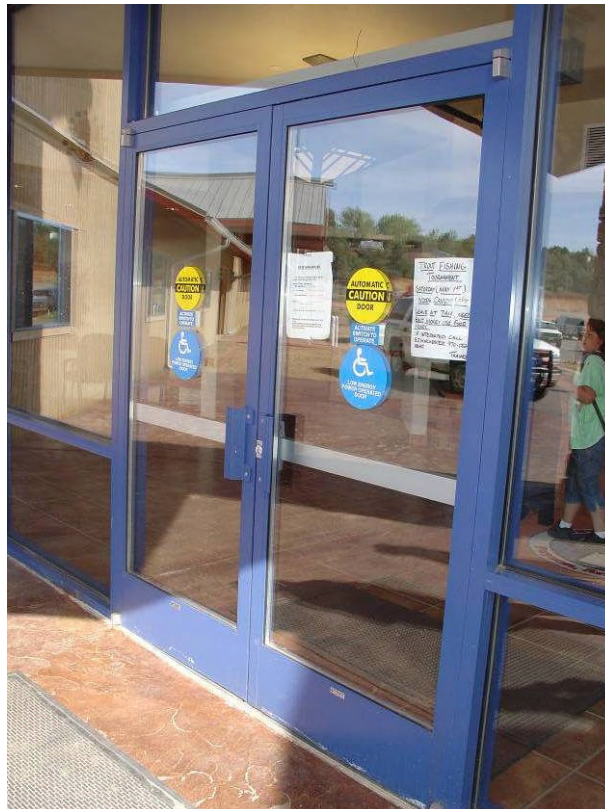
The entryway had an automatic double door entrance, with prominent signage and an easily operated push button. As with the entry, there was no problem with the exit, using a crash bar to push it open.

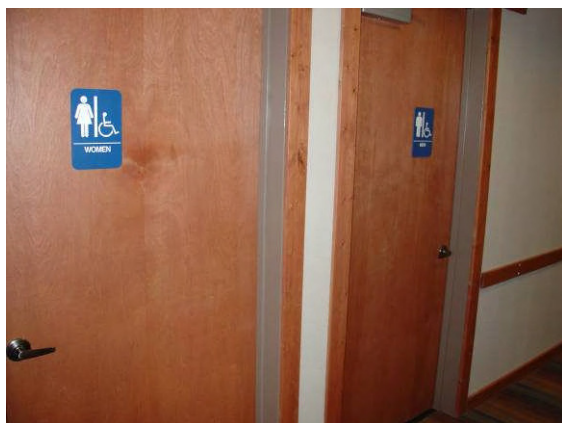
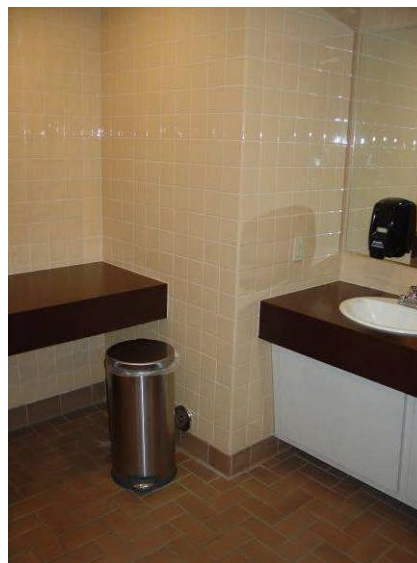
The hallway restrooms for the public were clearly marked as accessible, with Braille signs. The doors had easy to use latch handles. The first restroom visited had a sanitary hospital trash can, with a foot pedal. It is an effective trash can for preventing the spread of germs, but could be hard for someone with mobility impairment to operate. However, given the high incidence of diabetes within the tribe, and a diabetes case worker office in the courthouse, the possibility that courthouse patrons might dispose of insulin injection syringes and needles in the bathroom trash can likely necessitate the covered cans.

The restroom sink in the first restroom also would be very challenging for anyone using a wheelchair, since the well underneath the sink was closed off by a wooden cabinet area. The faucet had a lift lever on its top, with the soap dispenser placed directly over the sink on the mirror. The survey generally recommends placement of the soap dispenser to the side, to permit easier access, but still over the sink, to prevent soap on the floor. The toilet area had appropriate grab bars, but may have presented an entrance too narrow for a wheelchair to pull directly up to the toilet for close-proximity transfer. In the men's room, the urinal was sufficiently low to permit use by someone in a wheelchair, which is very positive, but the aisle leading up to the urinal, formed by the side of the stall and the wall, was fairly narrow. The restroom represented

a good effort at a retrofit for accessibility, but presented confining and somewhat challenging use limitations.

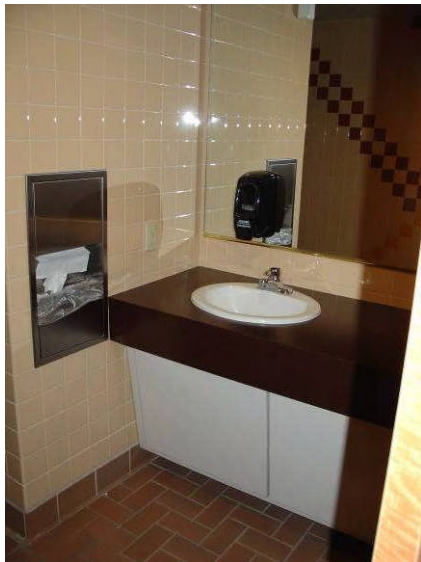
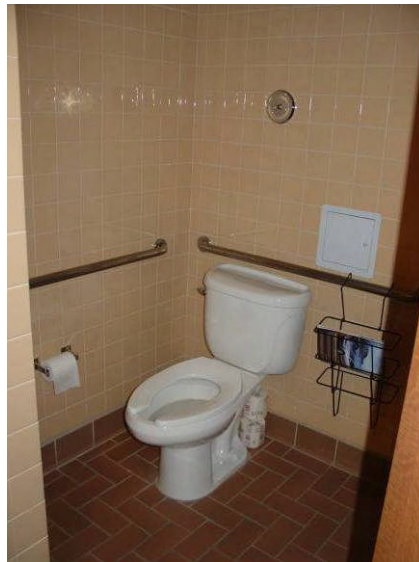
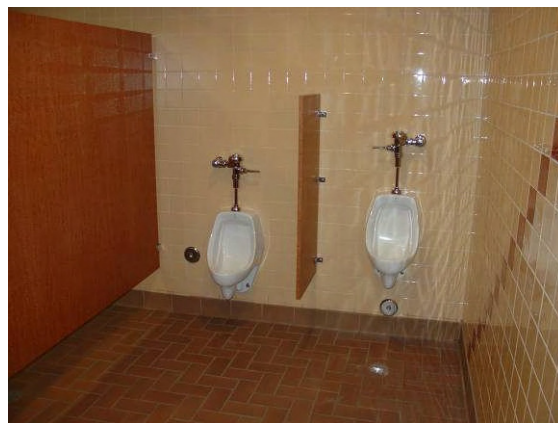
The second restroom visited had a low height urinal for a person using a wheelchair, which was also very accessible in the area surrounding the urinal. The stall was fully equipped with grab bars and had sufficient room for a wheelchair transfer immediately next to the toilet. The second restroom also had a sanitary, foot pedal-operated, covered trash can. The sink had the same wood coverings of the pipes, and the placement of the soap dispenser was over the sink on the mirror, making reaching it difficult. The room had a personal effects counter, presenting a more sanitary option for personal items such as medicines and injectables, and even food packages, that persons with diabetes would benefit from.

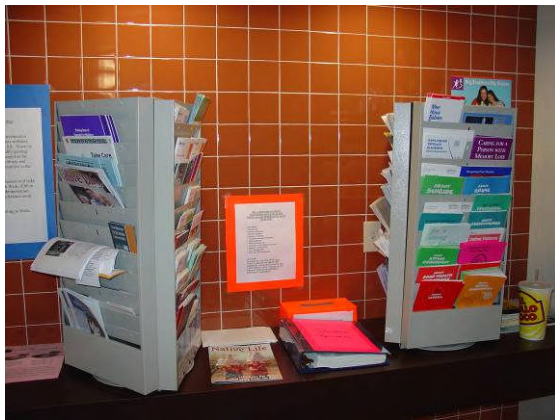
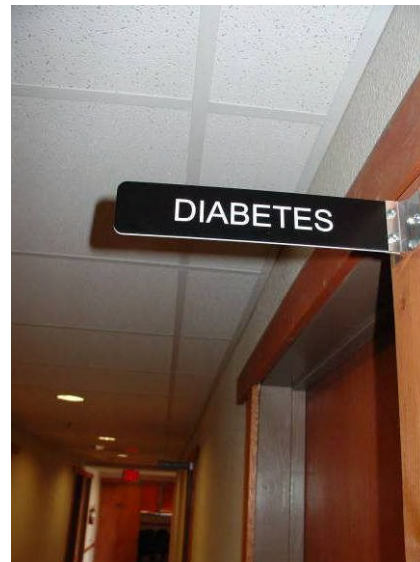
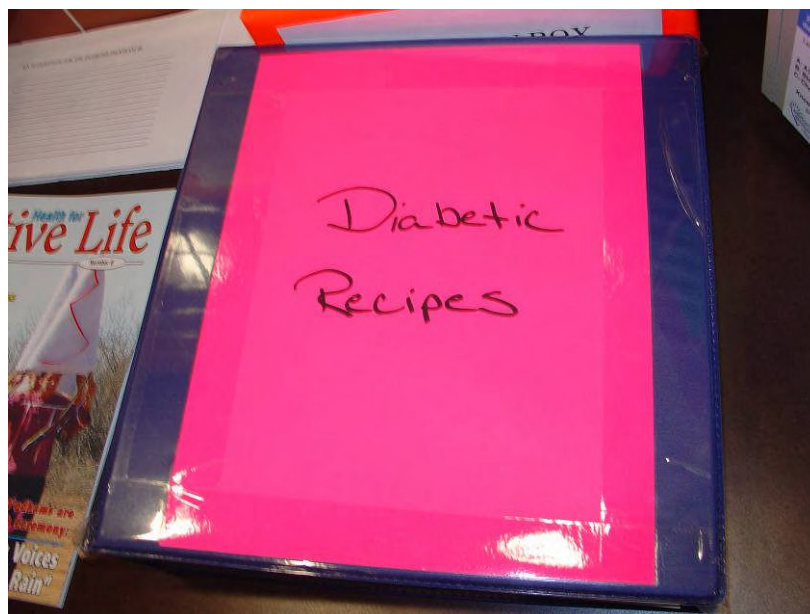
There is an extensive variety of pamphlets displayed in racks which describe social and disability services within the tribal facility for its members as well as for the greater community. The informational display was prominent and extremely helpful.

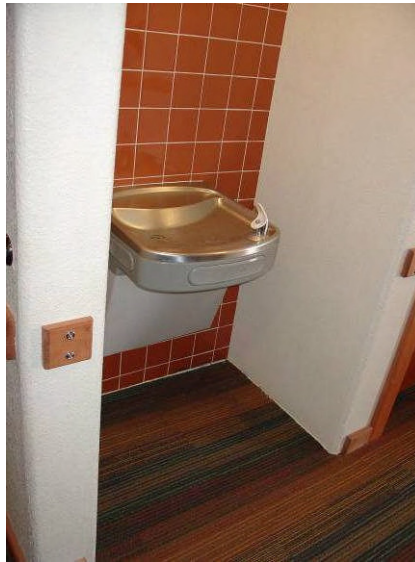
All hallways were sufficiently wide. The carpeting throughout posed a slight challenge to persons using wheelchairs and walkers, but was very safe for persons using crutches or canes. Throughout the survey in Arizona, teams continued to look for the ideal solution to supporting the needs of users of wheelchairs and walkers to have the smoothest surface possible, and persons using canes and crutches to have a slightly rough surface for sufficient traction. A good compromise seems to be rough tile floors.

The hallway had a fully accessible water fountain with an easy to use, front-push button.

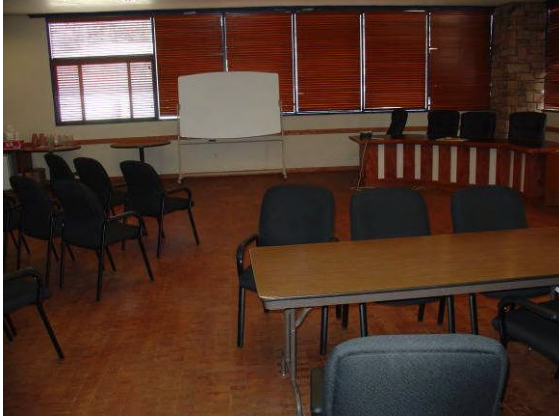
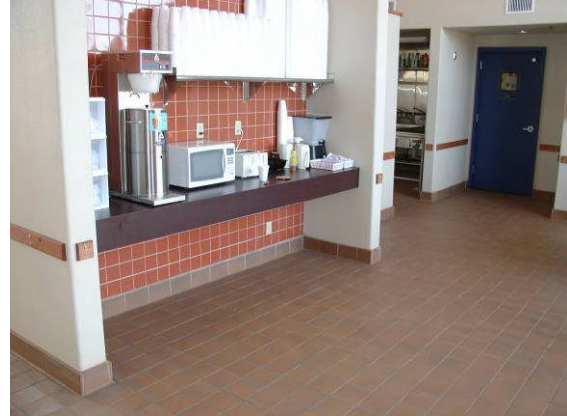
The team visited the room where the Tribal Council meets and which is also used for other tribal functions. It was accessible and possessed sufficiently wide passage and turn areas. The entry doors were accessible, with latch handles, and appear normally open. Refreshments are often served during meetings and events and the food service counters were low and accessible permitting a wheelchair to be wheeled up close to the appliances. An emergency first aid kit was prominently placed on the wall in the cafeteria.

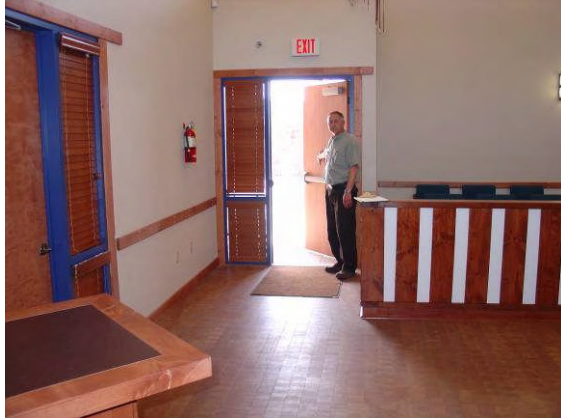
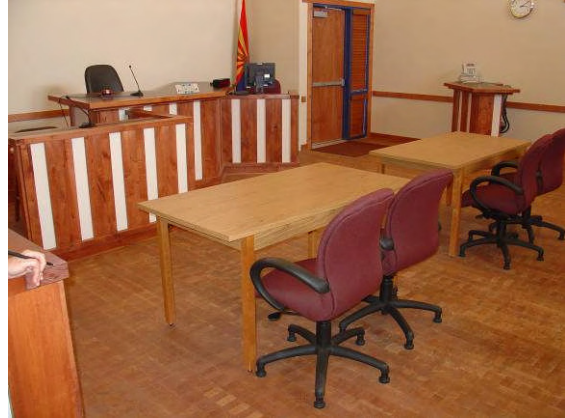
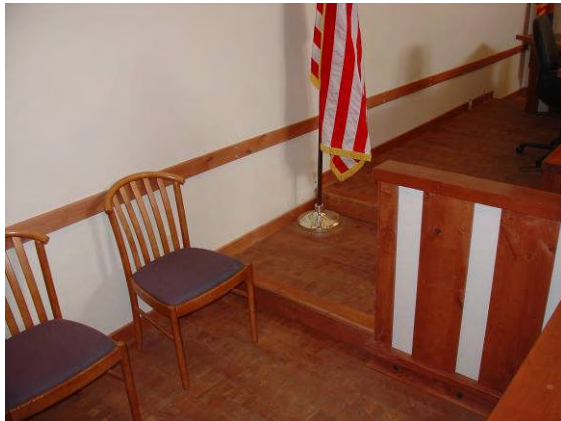
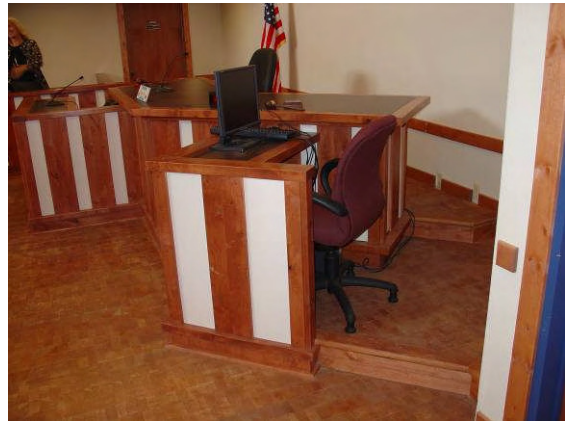
The courtroom had an entrance from the main courthouse that was a double door, latch handle entrance, and also had another double door, crash bar entrance from the outside of the building. A final entrance was to the judge's left, and opened through a single door with crash bar, to the exterior of the building. The wood floor was both easily used by wheelchairs, and also safe for persons using canes or crutches. The entryway from the gallery to the well of the courtroom had no gate, which made it convenient for persons with disabilities. The gallery had removable chairs, with sufficient room for several wheelchairs. Counsel tables were at wheelchair height and could be used by a wheelchair user.

The witness stand was elevated by one step, as was the jury box. A removable ramp could solve the access issue for either one.

Court facility staff might benefit from portable ramps for the witness stand and jury box.

The Tonto Apache Tribal Courthouse represents a generally accessible building for a community with comparatively high incidence of disease, leading to disability. Personnel responsible for administering the facility seemed appreciative of the needs of the disabled. Slight modifications to the courtroom in the form of ramps would significantly add to existing accommodations.
